MAL AYMM

Survey Date: 1/08/2022 Survey By: SIL

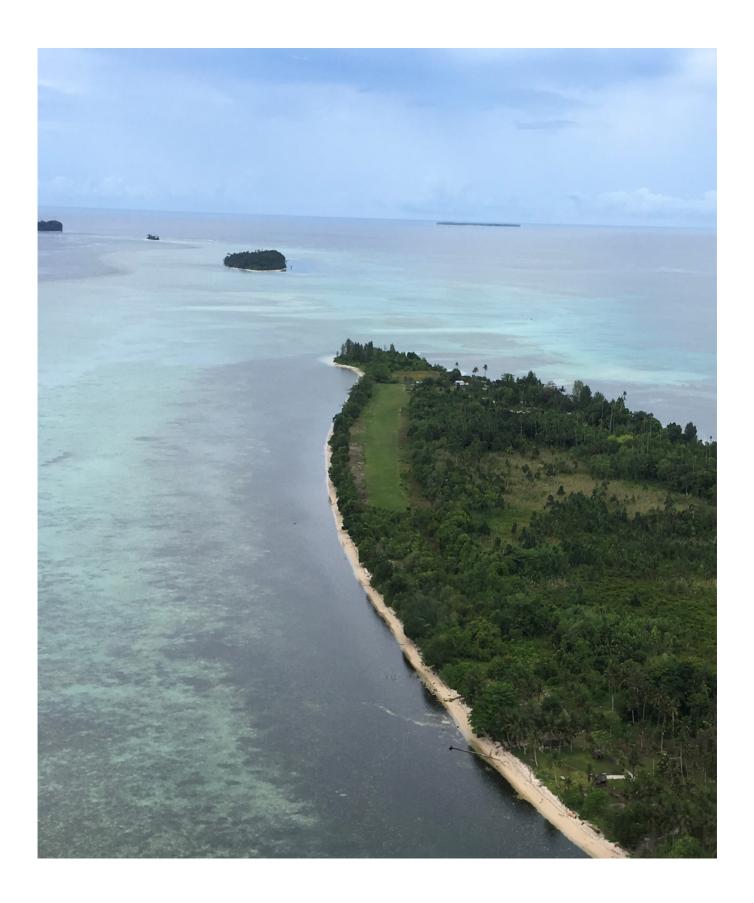
Tes								
Elevation 6 ft	Runway 01X 19	Length 614 m		Slope 0 %		Width 25 m	Freq 120.1	
Class D	Circuit LH	Surface Grass/cora	al		Stra	Committal Straight ahead at T.D.		
	1000.	Data SIO, NOAA, U.S. Na Image Landsat / C	Copernicus		10000	Slope TDZE 6' T	e 0 % Coogle Ear DZ Slp 0%	
		OTES	RWY	10%	15%		OTES	
LD01 261 1	N-1 Based on 8	584m	LD19	426	N-0	Based on 56	62m	
TO19 280	169 Based on t	584m	TO01	326	216	Based on 56		
ISA+15=30°C

CTN: Trees on both ends. Draggy sandy surface CTN: Eastern edge of airstrip in the middle of strip may be very slippery when wet.

Condition: Fair, Soft spots. Grass over crushed coral.

Consider getting a strip report prior to the flight because it is a long way to fly and return due to an issue with the runway.
