PC-6
SP
 Special
 Procedure

WAJJ 104nm
 VHF **123.0** Elev(ft) **2100**
 Lgth/Width(M) **344 / 16**

Marbata MRB ZZZZ
 Wind Time: **10:00**
 Precip: **No** | GPS **+5**

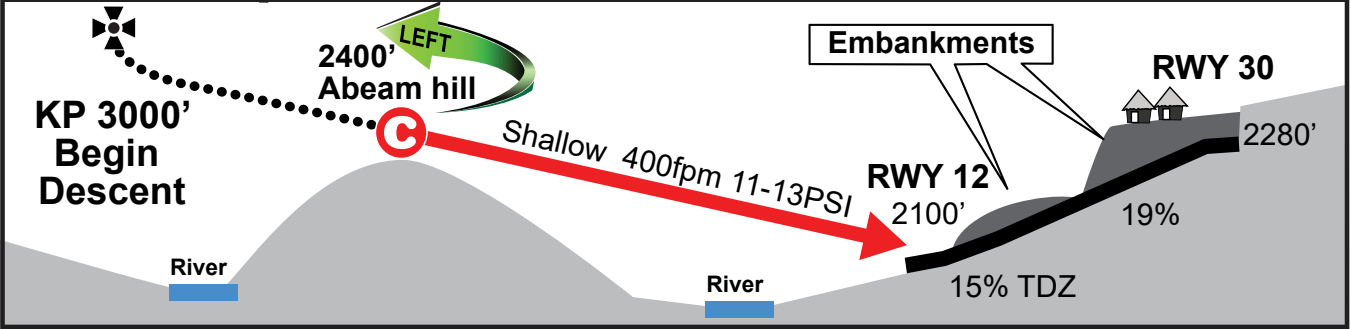
Runway in a bowl. Very steep and relatively short. Do not accept windy or turbulent conditions. Good surface with 16m rollable width, but watch for erosion problems. Large parking area.

↓ **12 Landing -0 / 2660 kg**
 ↓ **Go-around:** Immediate left turn follow river north.
Commit Point: 2400' abeam last hill on final
Can't Stop: Go into embankment on top of airstrip

↑ **30 Takeoff -0 / 2800 kg** Straight ahead departure clears all obstacles with margin.
 ↑ **Abort:** Committed at brake release. Do not go off left side or end. Go into embankment on right at 75% of runway.
Departure Emergencies: Lower terrain: immediate right turn after takeoff

Runway Inspection Information: Please report notams or needed chart changes. Monitor condition of runway extension (approach end). Erosion problems develop quickly due to steep slope.
